STS-107 Columbia Reconstruction Report

NSTS-60501

JUNE 30, 2003

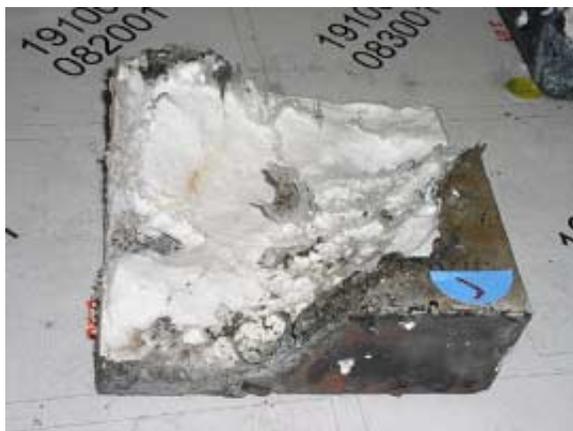
Item 85472

The tile (85472) is located inboard and aft from LESS access panel number 9 is the third most western tile found in the debris field. The design thickness was

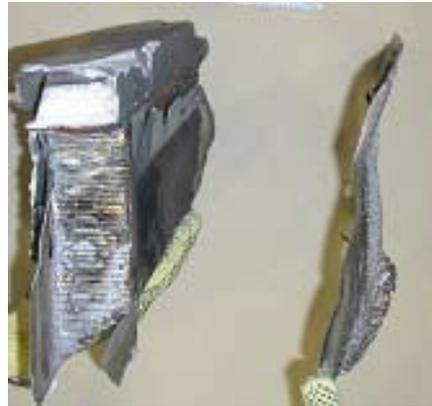
Item 21066, 22510

All of the left hand and right hand LESS access panels for the glove region were recovered with the exception of the right hand 5 upper and lower panels. The damage to the upper panels varied from relatively intact panels with tile to only portions of aluminum facesheet, as depicted with left hand panels 5 and 6 (21066 and 22510).

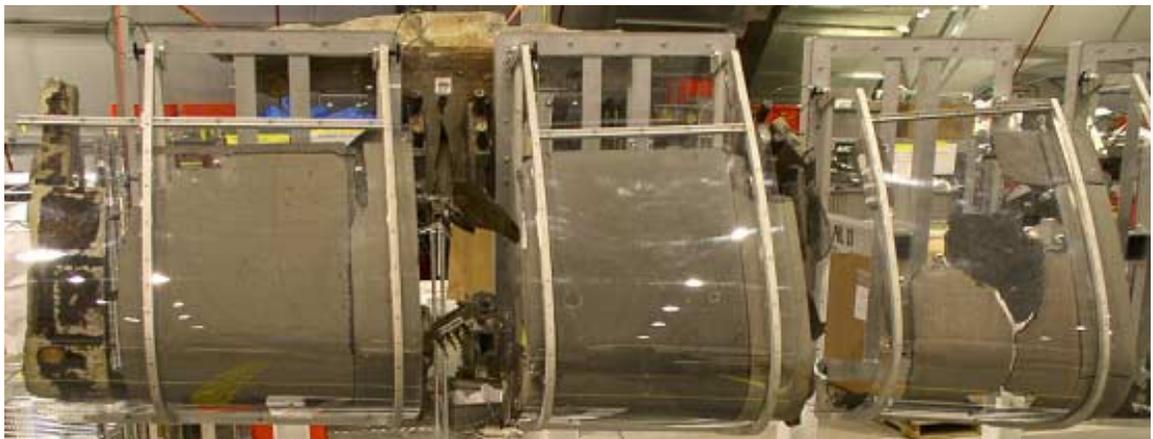
Left Hand RCC Panels 1, 2, and 3

All the RCC pieces in the glove region have fracture surfaces without signs of thermal erosion, though some of the fracture edges have substrate oxidation. The majority of the RCC lug clevis attach fittings were recovered. Uniform thin deposits on the interior of the panels contain Inconel, Ceracrhrome and aluminum at all deposition layers. The largest source of aluminum is the wing

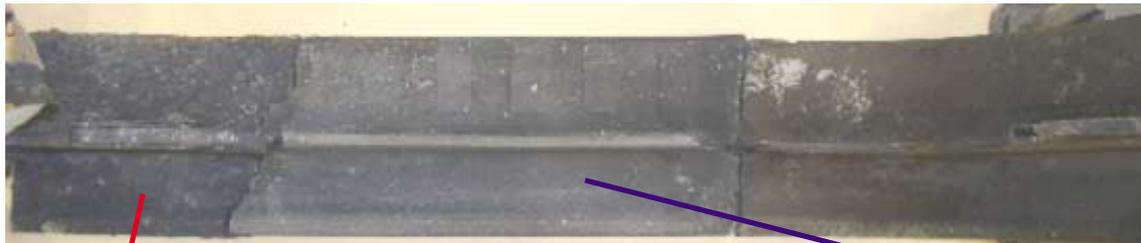
Deposits

based on deposit levels. Panel 2 and its associated gap seal have a heavy concentration of metallic deposits on one side of a fracture while the mating fracture surface is completely free of deposits. This condition is found on the gap seal (64823, 58575, 18474) where the middle

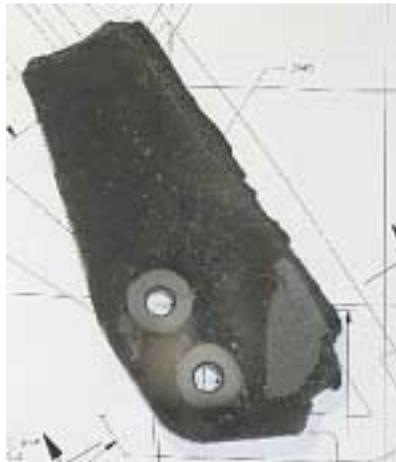
Item 26014

Panel	Lug Location	Item	Hardware Condition
7	Outboard	26014	Missing all hardware, except split bushings
8	Inboard	17957	Partial clevis, split bushing, aft bushing, no bolts
8	Outboard	61143	Missing all hardware, slag deposits in holes
9	Inboard	N/A	Lug was not recovered
9	Outboard	29741	Missing all hardware, including gap seal hardware
10	Inboard	34713	Missing all hardware, except one bolt with split bushing

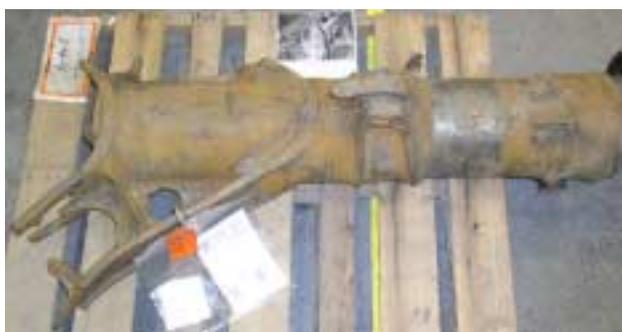
Item 12697

On the upper cylinder (12697), the gland nut threads are melted for two-thirds of the circumference and the uplock lug is melted away. The lower lug of the downlock link is attached and melted. One leg of the clevis is more than 80% melted away. The upper portion of the cylinder has extensive melting and distortion. The

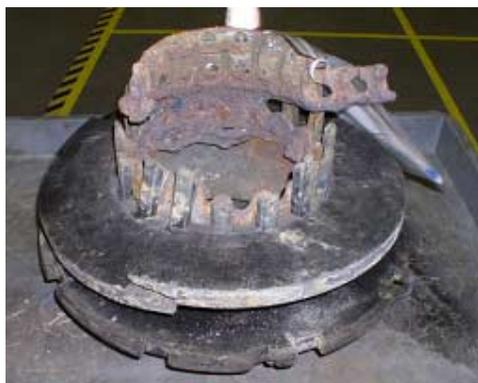
Item 1805

conditions ranging from intact to fractured small pieces. The left hand outboard brake body (1805) was recovered and has extensive thermal damage.

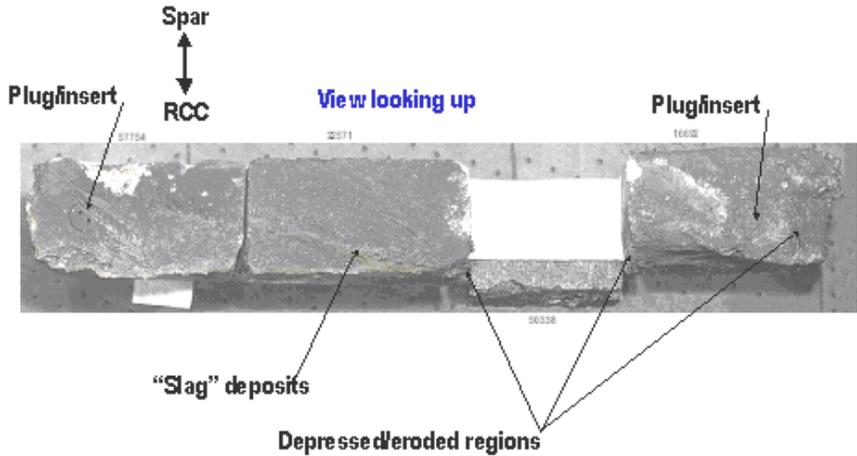
Figure 9.3. Top view of reconstruction lower left LESS Carrier Panel 9.

Evidence of overheating and slumping was observed on three LI-2200 Lower Left Carrier Panel 9 tiles adjacent to left hand RCC panel 9. The item numbers of tiles are: 16692 (V070-199716-048), 22571 (V070-199716-052) and 57754 (V070-199716-054). Figure 9.2 shows the simulated configuration of the carrier panel tiles. Depressed/slumped and eroded regions were observed in two of the three tiles (Items 16692, 22571).

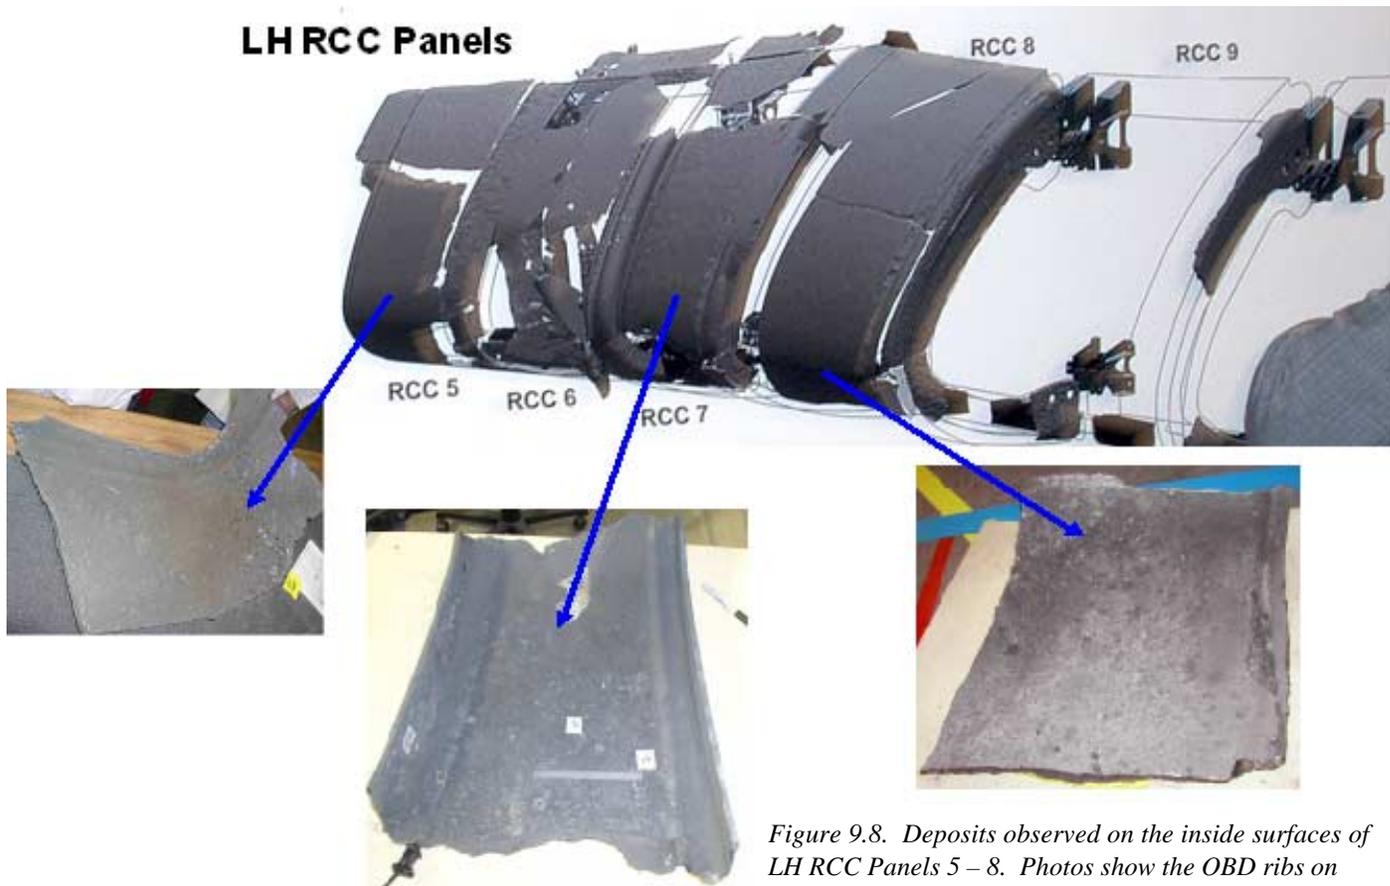
Figure 9.8. Deposits observed on the inside surfaces of LH RCC Panels 5 – 8. Photos show the OBD ribs on the Left and INBD ribs on the Right.

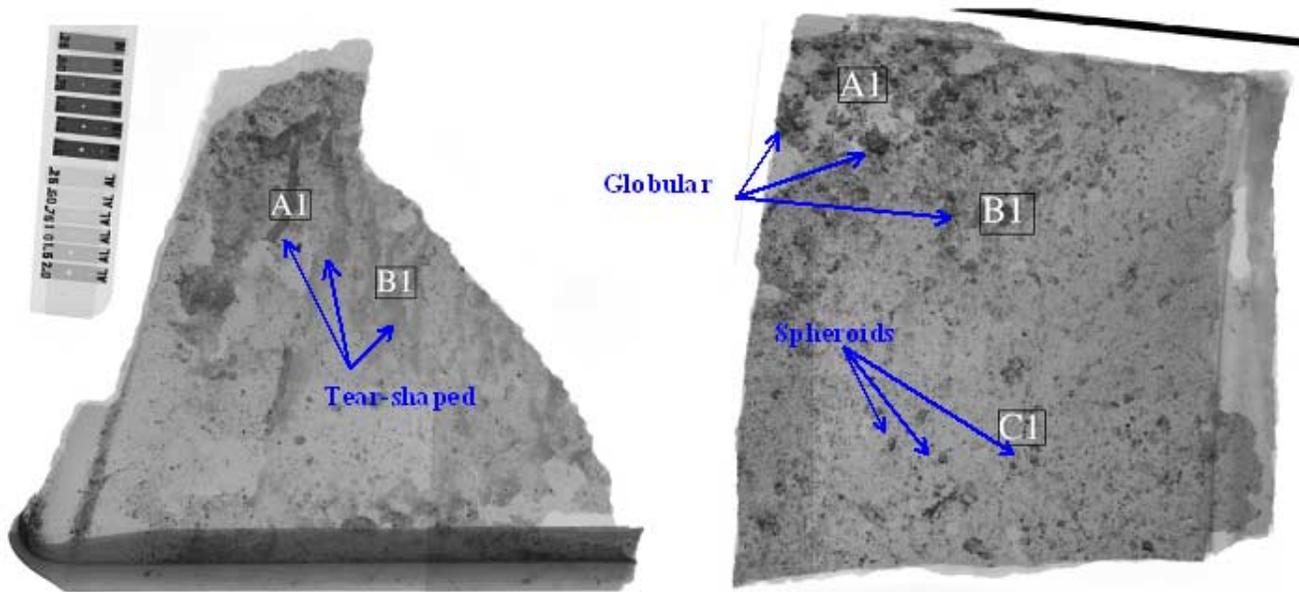
- The inverse radiographic response of heavier materials compared well with that of an IN718 standard
- Darker areas in the inverse radiographic images compared with the Inconel standard
- Aluminum and Cerachrome gave a similar radiographic response despite their diverse material characteristics
- Four types of deposit patterns were identified from LH RCC Panel 8 (Fig. 9.9)
 - Uniform thickness
 - Spheroids
 - Tear-shaped
 - Globular-shaped
- Other RCC panels imaged had Uniform thickness deposits

Figure 9.9. Types of deposition patterns observed on radiographic images of LH RCC Panel 8 pieces.

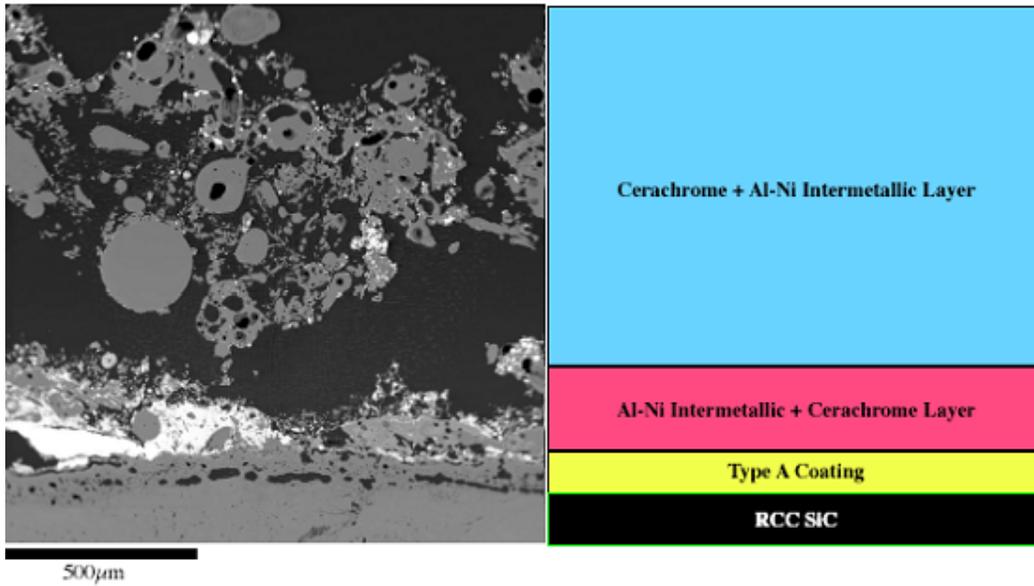
Figure 9.12. Cross-section of LH Panel 7 Upper (Item 31985)

- spanner beam, insulator foils, and other RCC fitting materials
- 3. The first deposited layer contained both Cerachrome and Inconel but not aluminum
- 4. The final deposited layers contained heavy amounts of aluminum
 - Elemental composition was consistent with Al 2024 alloy
- 5. Deposits on the OML apex of Item 2200's fracture surface were molten Cerachrome with significant porosity, and some sodium and minor amounts of copper were observed
 - Indicates that the deposited Cerachrome was mixed in with Type
- Aluminum was in either metallic or oxidized form

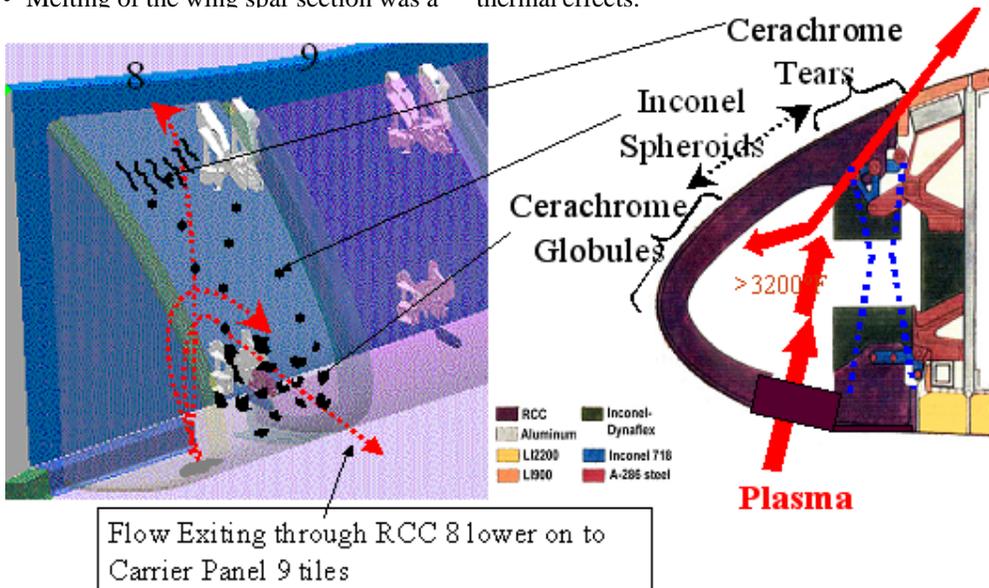
Figure 9.19. Schematic of deposition patterns analyzed near LH RCC Panels 8-9

Due to the absence of wing leading edge debris adjacent to LH RCC Panels 8-9, the duration of exposure and direction of plasma flow could not be determined. Additionally, sufficient material evidence near LH RCC Panels 8-9 was not available to correlate the configuration and geometry of the breach to the observed thermal effects.

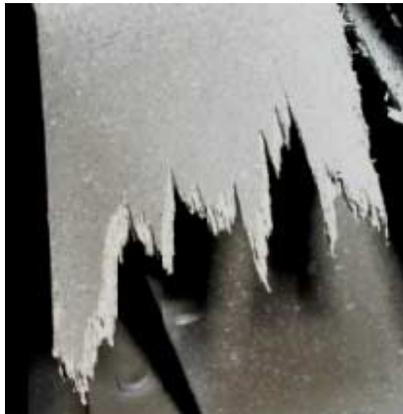
Broomstraw - Type of aluminum alloy fracture due to a high temperature failure of the material where there is incipient melting along the grain boundaries. At high temperatures very little applied stress is needed to fracture the material. Item 105 shown.

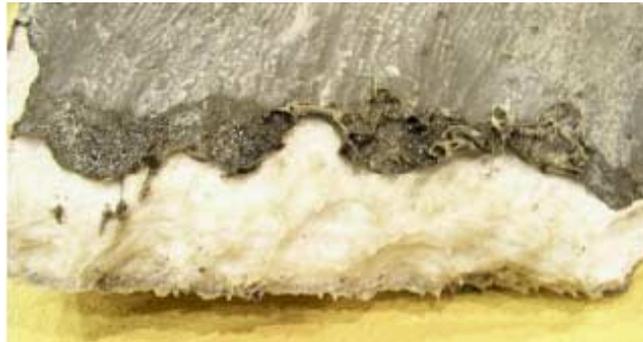
Glassification - Melting of the base silica material of a tile forming glass when subjected to temperatures over 3000 degrees Fahrenheit. The RCG must be damaged or missing for this to occur.
